## **A system for analysis of H<sub>2</sub> and Ne in polar ice core samples**

**Eric S. Saltzman et al.**

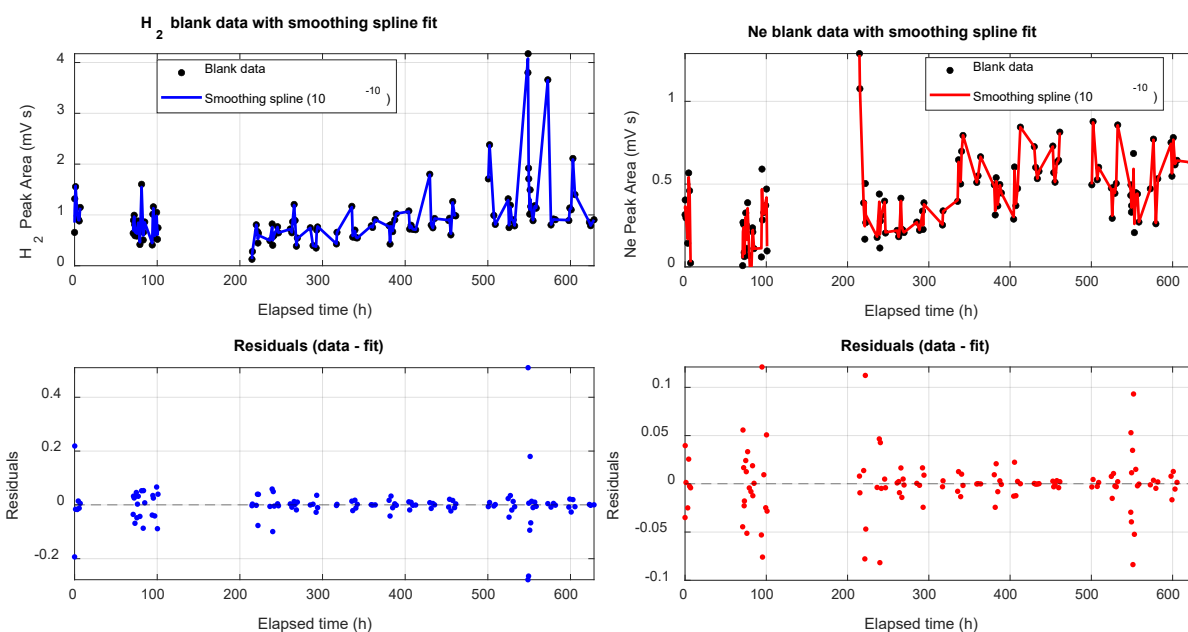
**Figure S1. Temporal variability of system blanks for the 1-month duration of the field project (n=117). Top left blue panel: H<sub>2</sub> blank peak areas (black dots) and smoothing spline (blue line). Bottom left panel: H<sub>2</sub> blank residuals. Top right panel: Ne blank peak areas (black dots) and smoothing spline (red line). Bottom right panel: Ne blank residuals.**

Figure S1 shows the temporal variability in the blanks during the field period (~1 month). A smoothing spline fit was used to interpolate between blanks. The H<sub>2</sub> blank peak areas ranged from 0.1 to 4.1 mV s, with an average of 0.96 mV s. Ne peak area varies from 0.1 to 1.2 mV s, with a blank average of 0.43 mV s.

We note that the variability in blanks and in system response was much larger during this field deployment than is typical for this system in the laboratory. This was due to a combination of harsh deployment conditions in a tent with highly variable temperatures, and a malfunctioning electronic pressure controller on the detector discharge gas that was not repairable in the field.

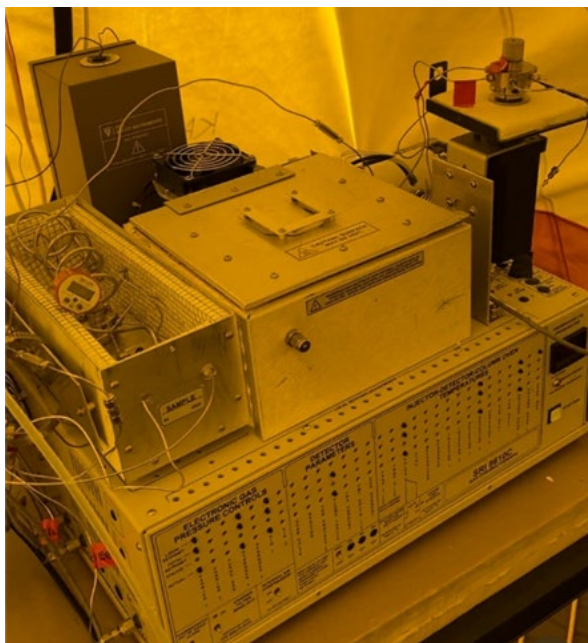
**Figure S3. Images of the instrumentation in the field. a) gas chromatograph with He-PDD detector, b) overall configuration of the extraction line and gas chromatograph with vacuum pump in white box below the table, c) close-up of left side of the extraction system without sample flasks; showing Nafion drier, d) close-up of right side of extraction line showing piston pump and associated electronics. All photos used with permission of John D. Patterson and Murat Aydin.**

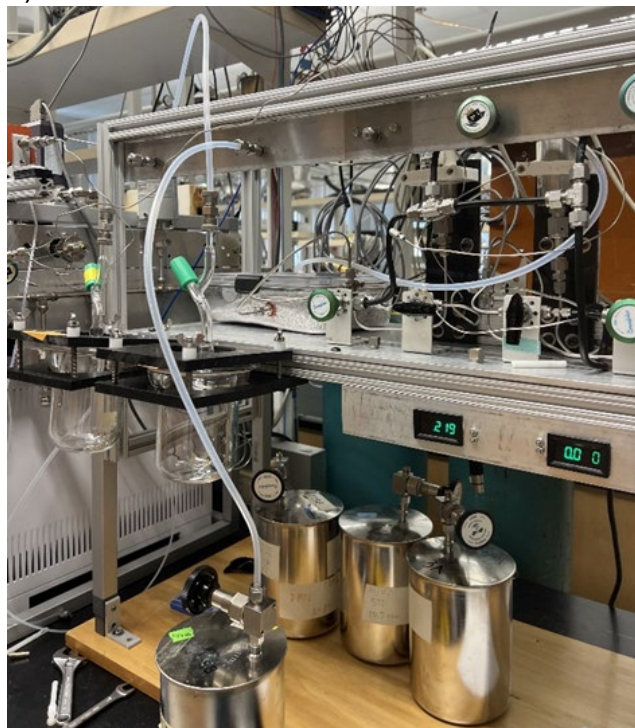
**Figure S4. Extraction line in the laboratory. a) extraction line connected to working standards for system calibration, with empty glass flasks, b) glass chambers sealed with ice core samples prior to melting c) close-up of glass flask containing an ice core sample about to be immersed in warm water. The plastic outer ring is visible at the top of the flange, d) top view of the glass chamber. The PTFE inner ring is visible. Used with permission of Miranda H. Miranda.**

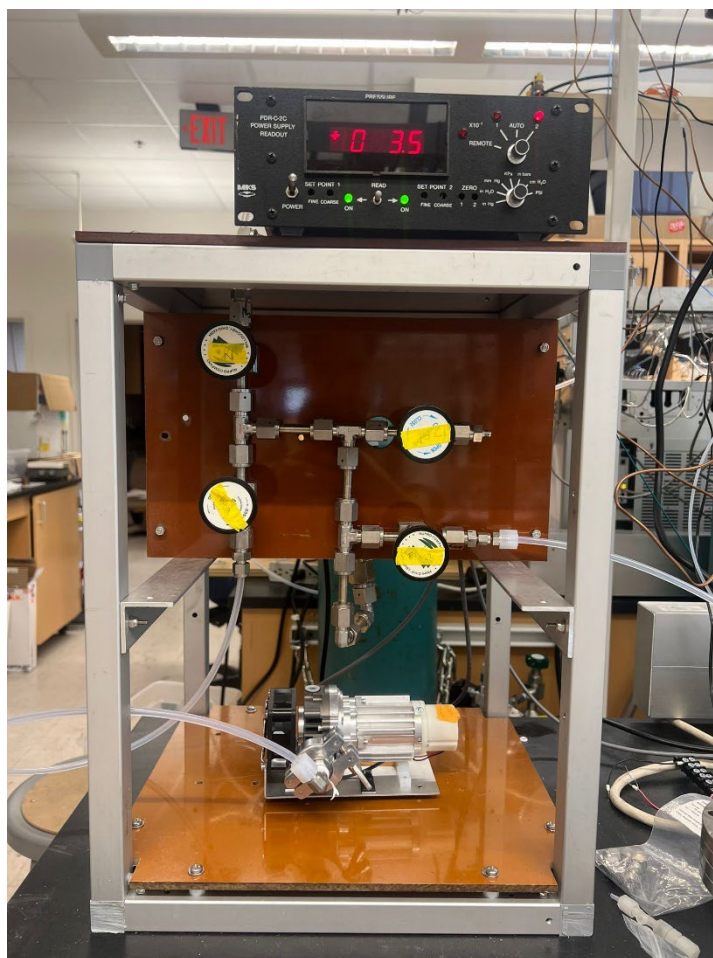
**Figure S5. Image of the dilution system showing bellows valves and pump. The Baratron vacuum transducer is mounted behind the panel. Used with permission of Miranda H. Miranda.**
