# Rugged optical mirrors for Fourier-Transform Spectrometers operated in harsh environments

D. G. Feist<sup>1</sup>, S. G. Arnold<sup>1</sup>, F. Hase<sup>2</sup>, and D. Ponge<sup>3</sup>

<sup>1</sup>Max Planck Institute for Biogeochemistry (MPI-BGC), Jena, Germany

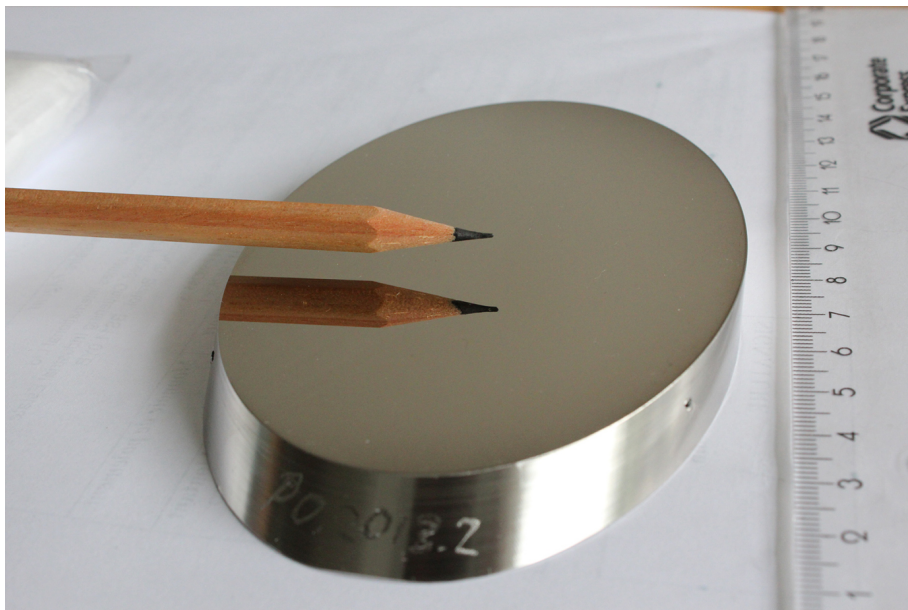
**Figure 7.** Stainless steel mirror with lapped and polished optical grade surface.

The rugged mirrors were designed to be drop-in replacements for the existing mirrors of the Bruker A547 solar tracker (a widely used model in the TCCON and wider FTS community). The principal shape of the mirror is a disc cut out of a cylinder with a diameter of 80 mm at an angle of 45°. The mirror surface is therefore a plane ellipse with a length of 113 mm and a width of 80 mm (see Fig. 7). This is almost the same design as the original Bruker mirror, only about 1 mm thicker. The mirror design for azimuth and elevation mirror is identical.
