Supplementary Information (SI) for

Intercomparison of detection and quantification methods for methane emissions from the natural gas distribution network in Hamburg, Germany

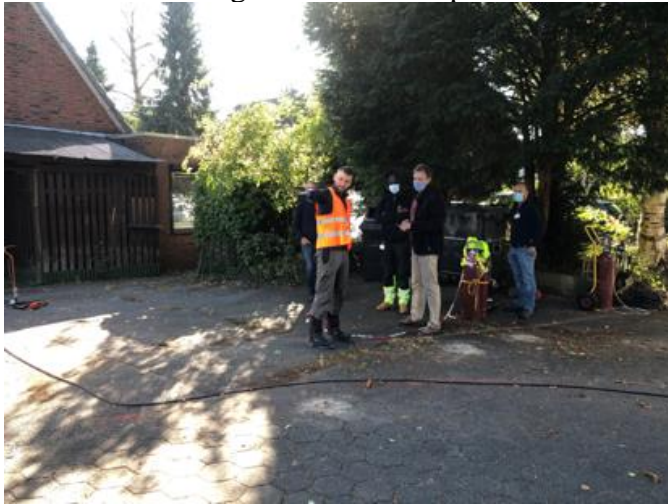
Figure S2 - Example of a visit at one of the locations, HH008, together with the LDC

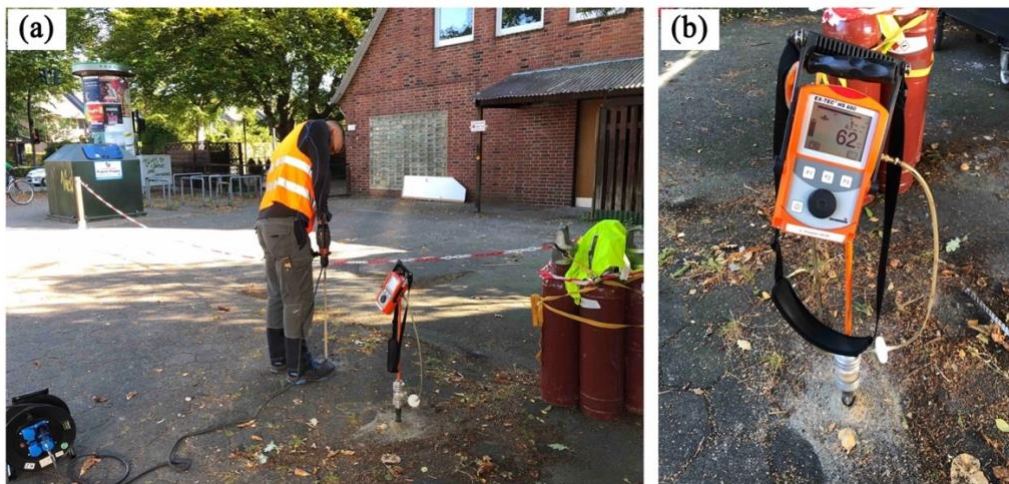
Figure S3 - Drilling holes around the surface-projected track of gas pipeline (a) and measuring the CH_4 mole percentage (b) to find the gas leak location, HH008

In this campaign we focused on 15 locations which were initially detected by mobile surveys and later confirmed as gas leaks by the LDC, except for 2 locations, plus 5 more locations which had been already detected by the LDC leak detection surveys. After sharing the locations with the LDC we visited the locations with the leak searching experts from the LDC (Fig. S2). When a leak had been confirmed, the LDC leak searchers drilled holes (Fig. S3a) and measured subsurface CH_4 volume mole fraction for each hole (Fig. S3b).

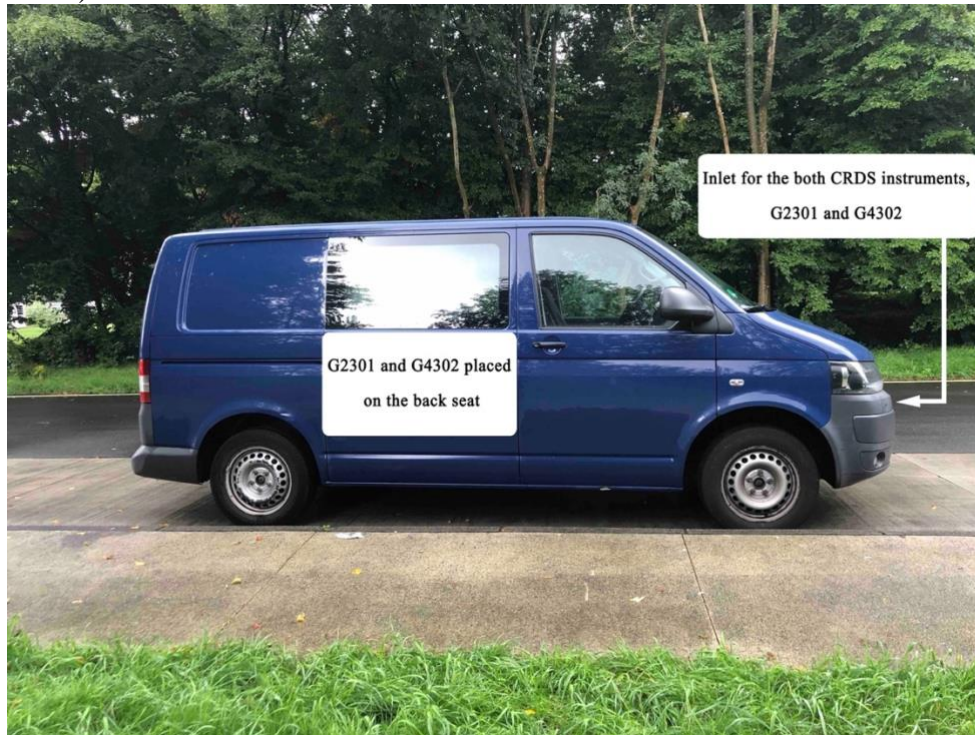
Figure S4 - Mobile measurements vehicle

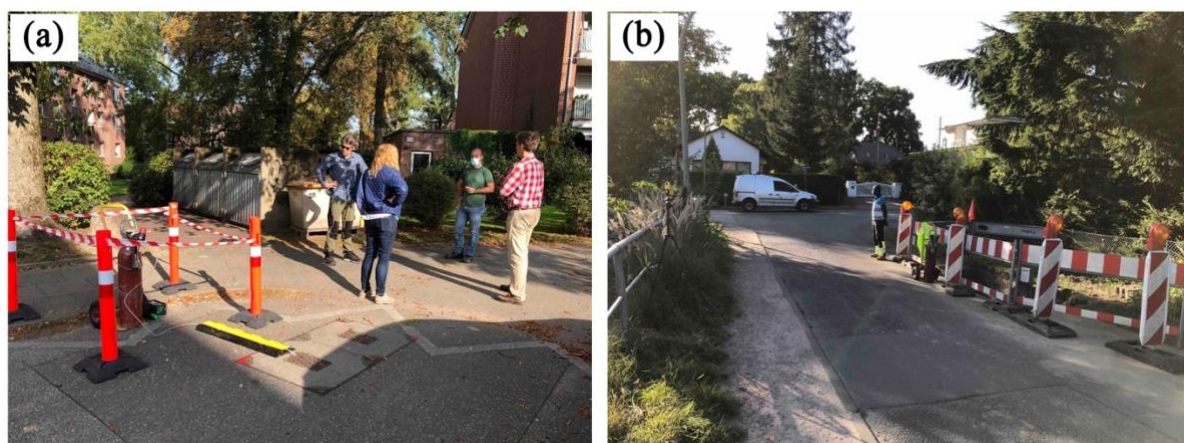
Figure S5 - Tracer method in static mode (a) at HH004 and in mobile mode (b) at HH014

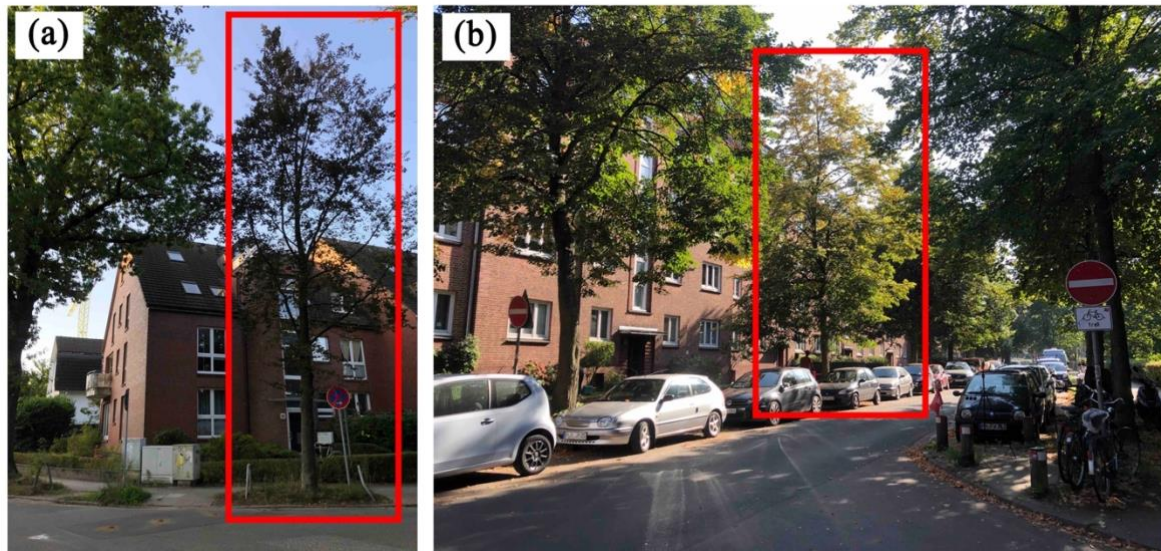
Figure S8 - Example of unhealthy trees (red box) affected by a gas leaks in close vicinity, HH004 (a) and HH010 (b)

Increased soil CH_4 content can also adversely influence vegetation. Methanotrophs oxidize CH_4 which lowers the soil oxygen content and consequently impacts soil quality and urban vegetation health (Schollaert et al., 2020). We observed on several occasions that the vegetation, especially trees, next to the leak locations were affected by the presence of a gas leak in proximity. Fig. S12 shows two examples from HH004 and HH010 where trees were affected by gas leaks.

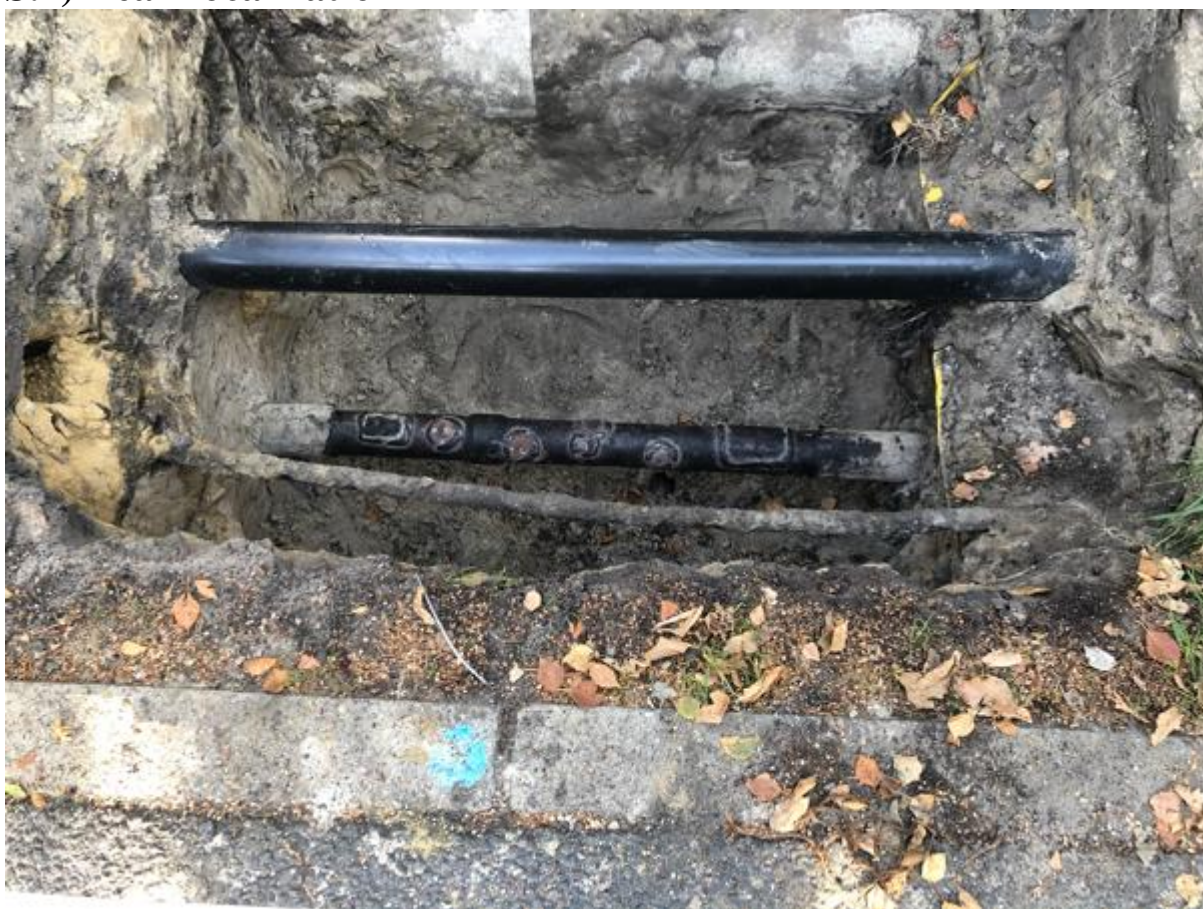
Figure S9 - The LDC reported 6 leaks on the pipeline at this location with total leak area of 5 cm², HH013

Based on the two CH_4 enhancements, which were more than 10% above background level on G2301, the emission rate 1.8 L min^{-1} was derived for this location. The leak was classified as A1 leak from a DN80ST pipeline which dated back to 1939 with overpressure of 30 – 60 mbar. The total leak area, 6 holes (See Sect. S.7) next to each other, was estimated $\approx 5 \text{ cm}^2$ which was due to corrosion.
